Manhole Inspection Summary

Manhole # S21K__037MH

Insp Date: **9/25/07 1:36 PM**

Location Address: **203 MONROE ST**

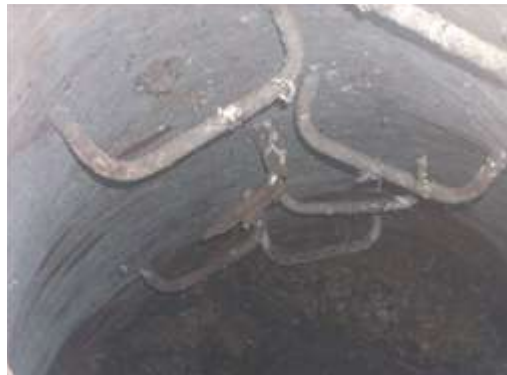
Defect 3

Count: **6** Missing: **1** ☒ **Corroded**

MISSING AND CORRODED STEPS

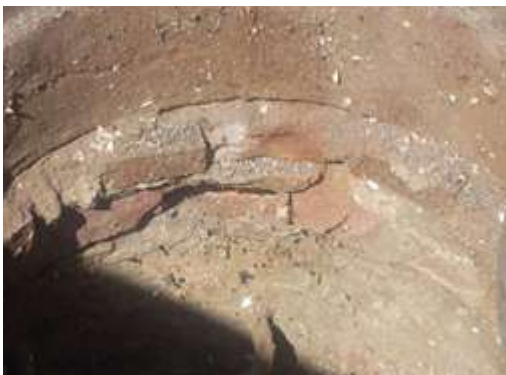
Defect 2

Condition: ☐ Sound ☐ Cracked ☐ Root Intrusion ☐ Loose Brick ☒ **Deteriorated**

CHIMNEY DETERIORATION

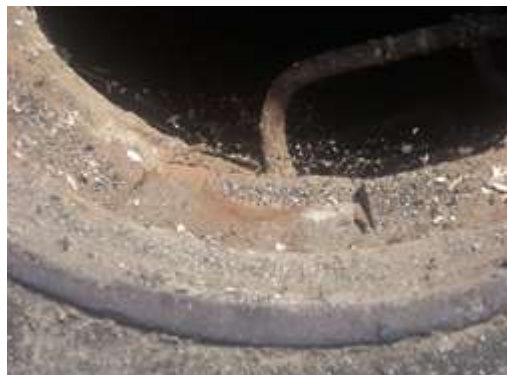
Defect 1

Offset: **2** (in.)

FRAME OFFSET

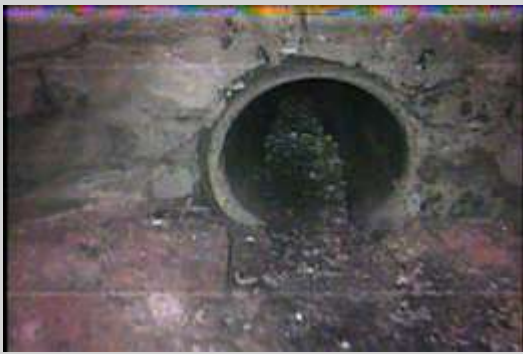
12 O'Clock Outflow

8 in. Circular Gravity Sewer
Pipe Out @ 12 O'Clock

Deposits: ☐ None ☐ Mud ☐ Sludge ☒ **Debris** ☐ Grease

Silt Depth: **1** (in.) Deposits Extent: **Light**
